**Flood Control Project Maintenance
Levee Inspections**

Fall 2012 Levee Maintenance Deficiency Summary Report

San Joaquin River Basin

Reclamation District No. 2094 Wathal

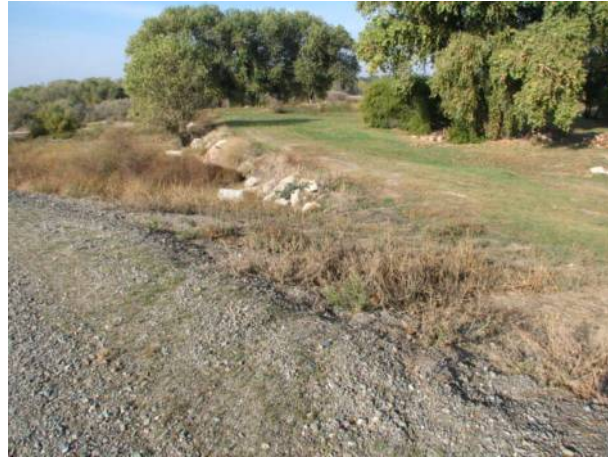
Levee Mile Report Line	4
Start Levee Mile	0.10
End Levee Mile	0.10
Location	Water Side
Category	Earthen Levee
Item	Encroachments
11/09/2011 Tire marks shown onto ramp from levee. Raised area extends to the trees in the background in the center of the photo.	
mkhashch_f_20120927_316.jpg

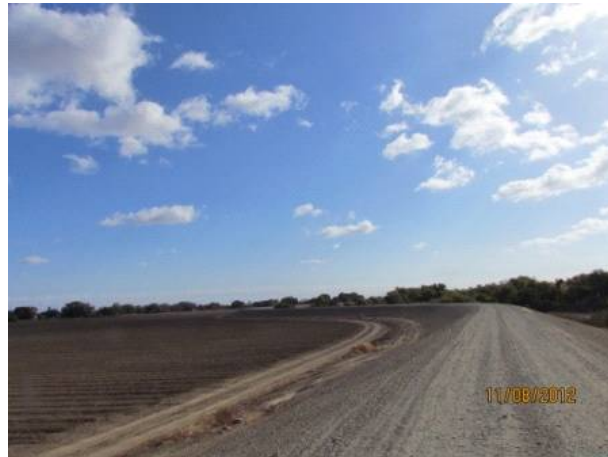
Levee Mile Report Line	5
Start Levee Mile	0.34
End Levee Mile	2.81
Location	Land Side
Category	Earthen Levee
Item	Vegetation
View of acceptable vegetation control on levee slopes.	
mkhashch_f_20121119_767.JPG

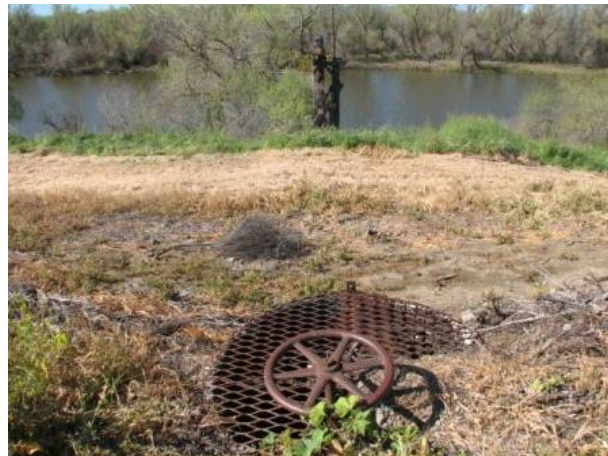
Levee Mile Report Line	6
Start Levee Mile	0.66
End Levee Mile	0.66
Location	Water Side
Category	Earthen Levee
Item	Encroachments
Irrigation intake on San Joaquin River. Positive closure device (sluice gate) on water side hinge points. Pipe is through freeboard portion of levee. Concrete stand pipe beyond landside toe.	
mkhashch_f_20120927_315.jpg

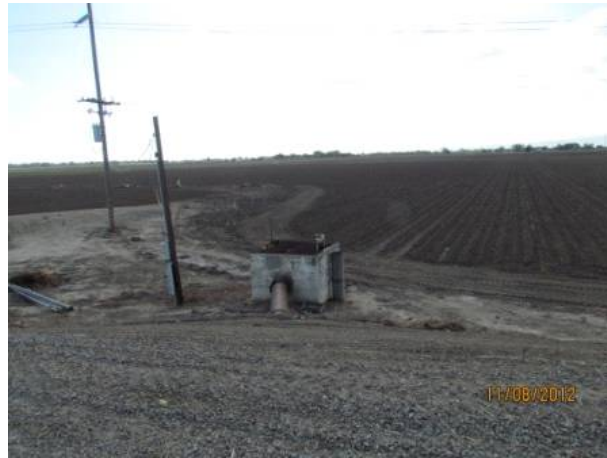
Levee Mile Report Line	7
Start Levee Mile	1.26
End Levee Mile	1.26
Location	Water Side
Category	Earthen Levee
Item	Encroachments

View of the irrigation pipe at landside toe.

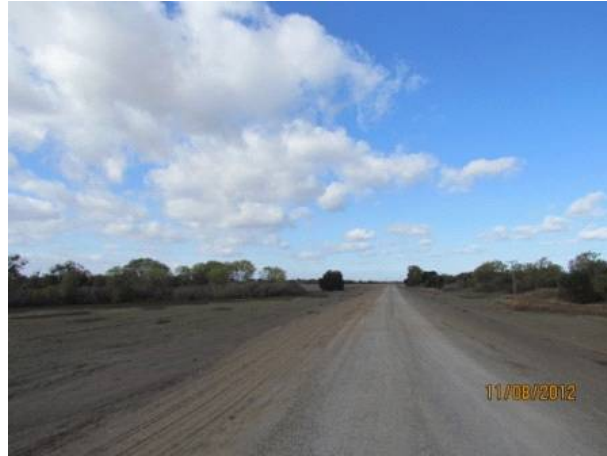
Levee Mile Report Line	1
Start Levee Mile	0.04
End Levee Mile	0.42
Location	Water Side
Category	Earthen Levee
Item	Vegetation

View of acceptable vegetation control on levee slopes.
